**Report on the
Open Web Steel Joist
Remediation Program
for the Province of
Newfoundland and Labrador
VOLUME 1 - REPORT**

**The Open Web Steel Joist
Task Review Board**

**Date: March 2003
Revised: May 2005**

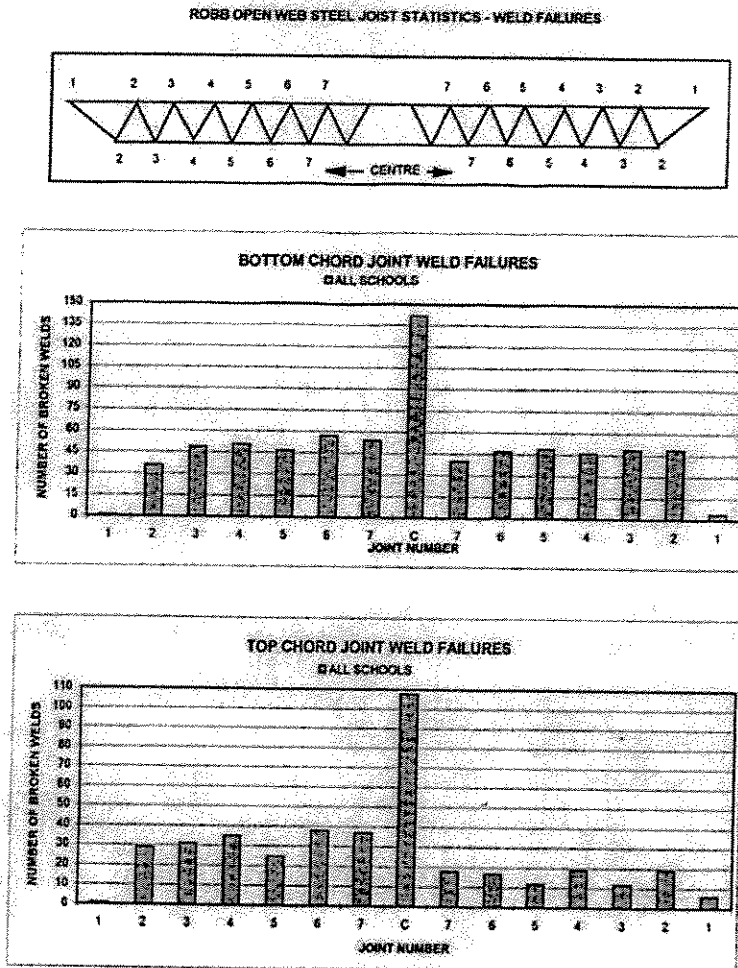
Figure 5: Weld Failure Charts

The random location of the failures was another indicator that there was a gross and widespread welding problem with Robb Joists. A characteristic nature of truss-like structural members such as open web steel joists, is that the stress on joints, when uniformly loaded, is the highest at each end and theoretically the lowest at the center of the joist. Given that the amount of welding did not consistently vary with location in the joist, it would be expected that the incidence of connection failure would increase proportionately with distance from the center of the joist span. A review of the following charts taken from the report, "OWSJ Load Test and Inspection Program", reveals that the failures were very random in nature. It should be noted that the spike at the centre of the charts represents more than one (1) joint. The random location of the weld failures without evidence of member yielding, was very conclusive evidence that Robb Joists had an inherent connection/welding deficiency. See Figure 5 below.

The random location of the weld failures without evidence of member yielding, was very conclusive evidence that Robb Joists had an inherent connection/welding deficiency.

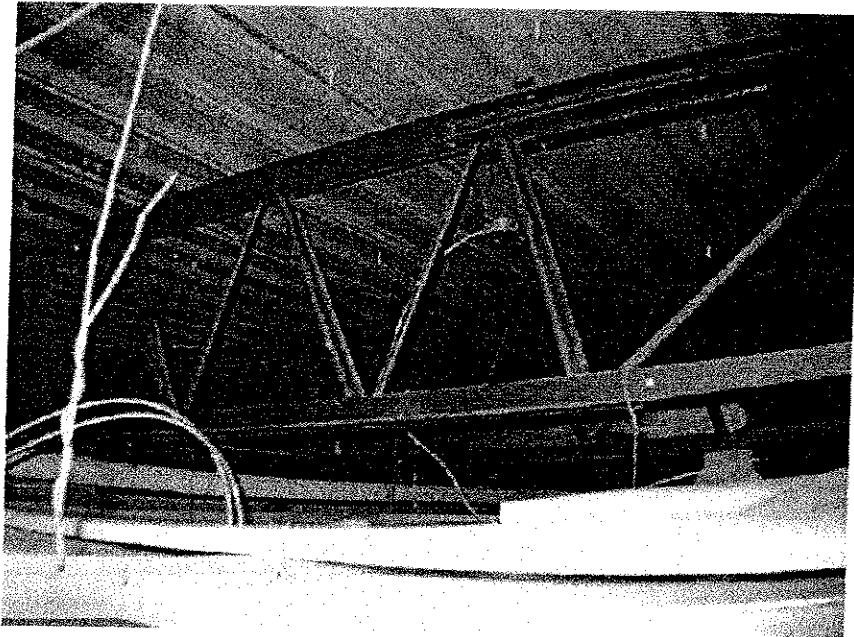
Photo 1: Joist J1 - Note Local Reinforcing Due to Transition to Two Story High School

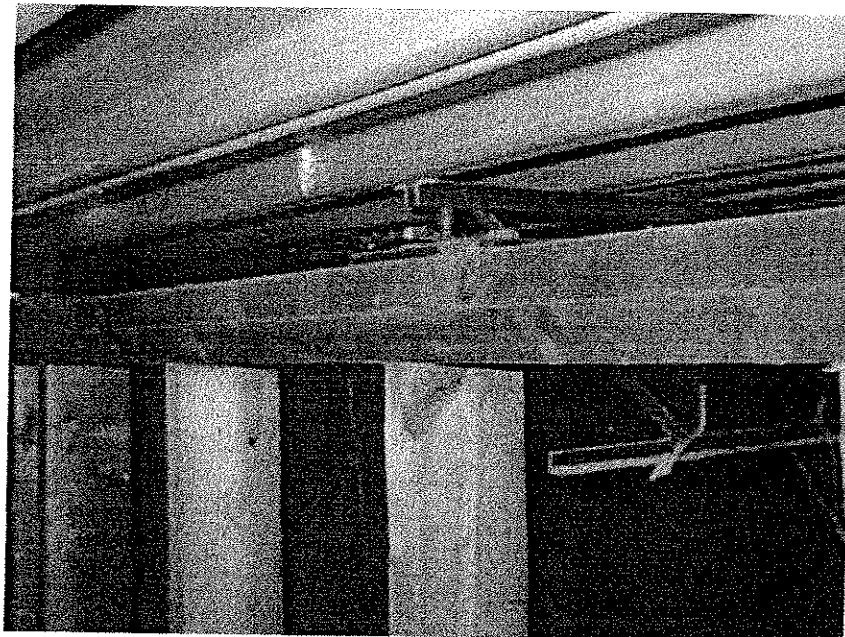
Photo 2: Typical Joist Shoe Connection to Wood Bearing Wall

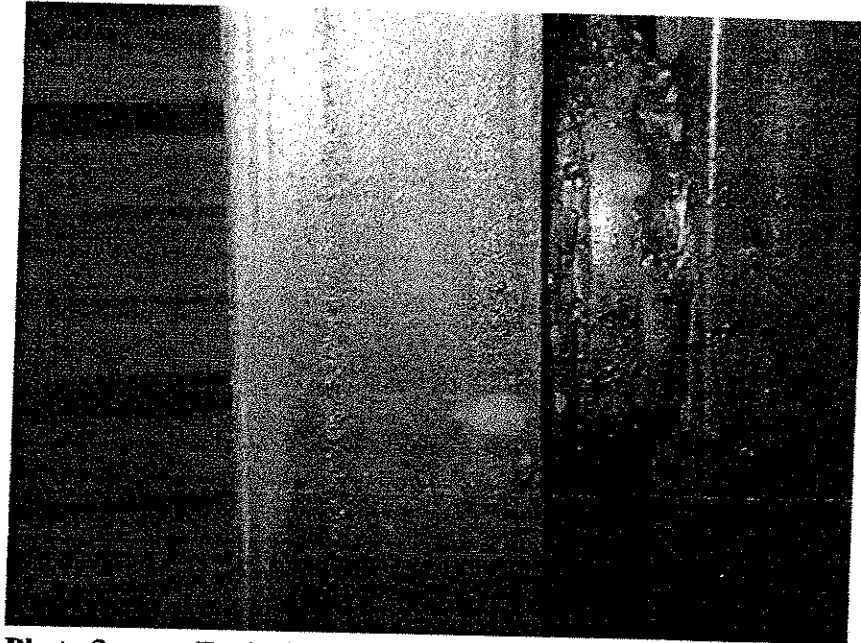
Photo 3: Typical Bottom Chord Panel Point Weld Quality

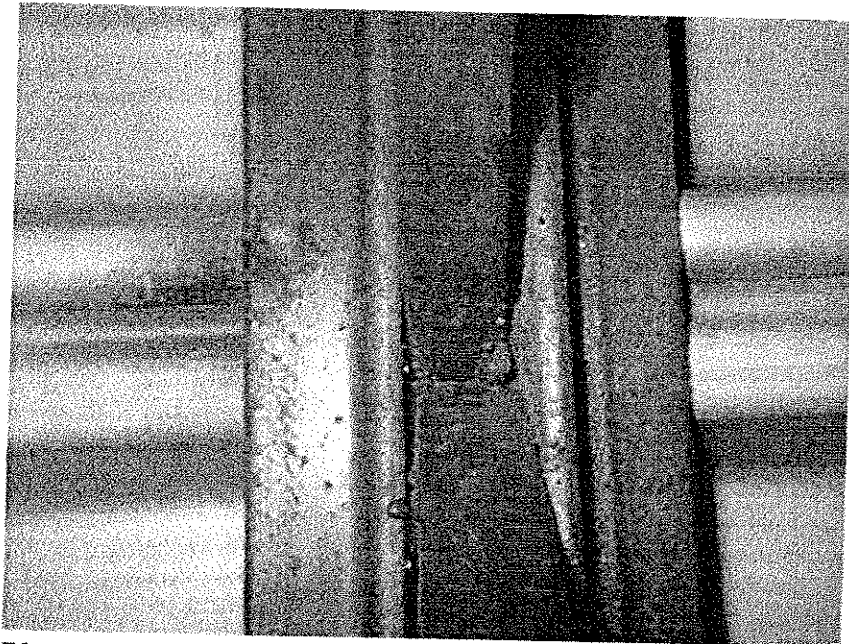
Photo 4: Typical "Puddle Weld" at Non-Continuous Top Chord Panel Point

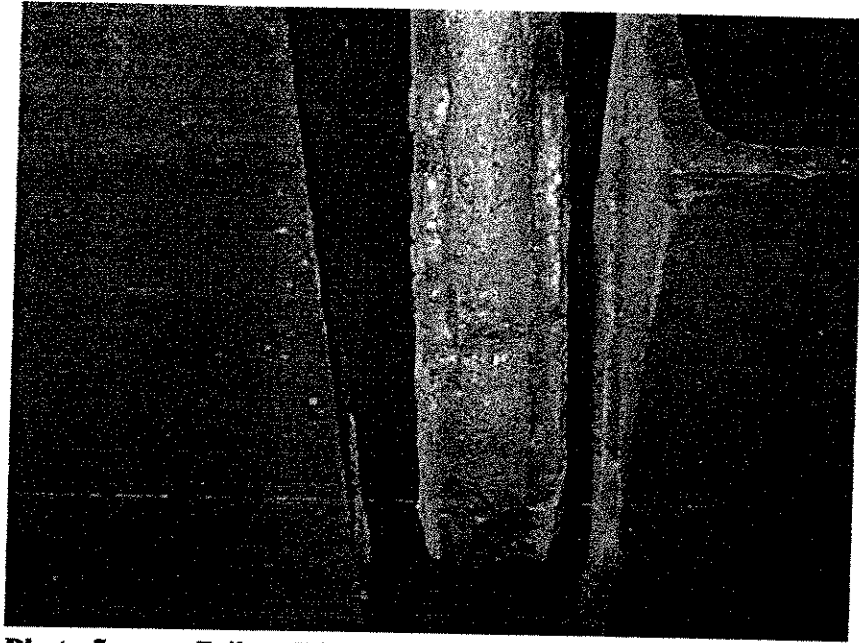
Photo 5: Failure Discovered at Panel Point 2 on Joist 1

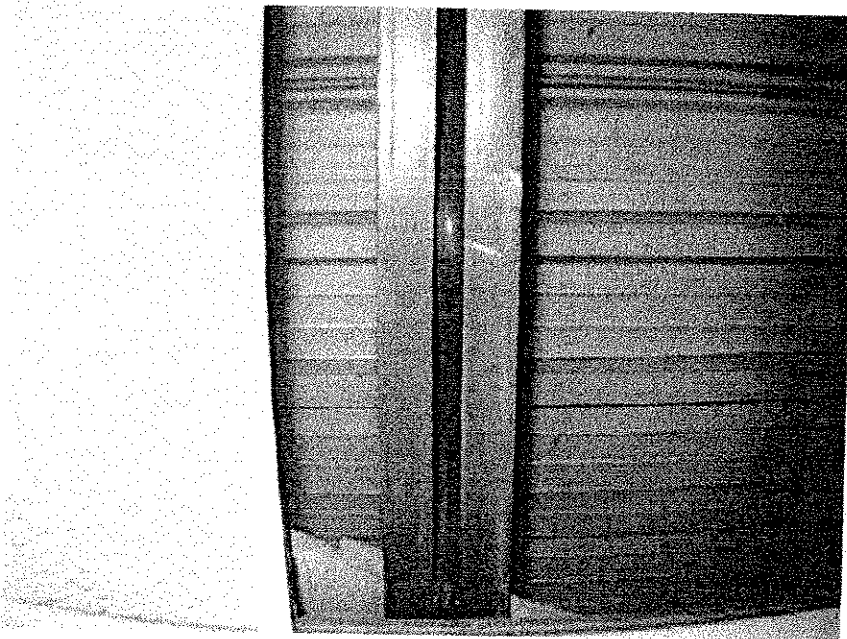
Photo 6: Non-Welded Joint Discovered at Panel Point 4 on Joist J147
