**ROBB ENGINEERING OWSJ's
UPDATED INFORMATION**

PREPARED BY: THE OWSJ TASK REVIEW BOARD

**PREPARED FOR: PROFESSIONAL ENGINEERS & GEOSCIENTISTS OF
NEWFOUNDLAND AND LABRADOR (PEG-NL)**

DATE: NOVEMBER 2006

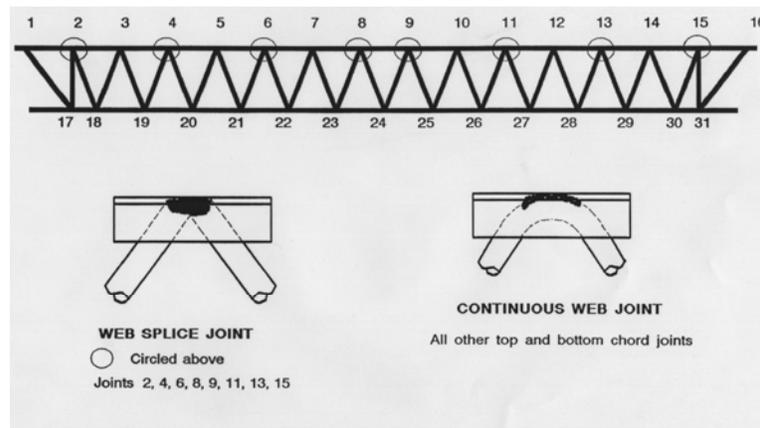
One of the more startling statistics that was reported in the above referred publication was that 8.3% of all joists inspected had one or more broken welds, which was based upon almost 7000 inspected joists. These weld cracks appeared quite randomly in both their location relative to the joist and their location relative to the building, although in some buildings, the cracks occurred in groups of consecutive joists. In addition to the weld cracks, there were numerous other weld flaws such as porosity, under cut, lack of fusion, etc. Virtually every joist inspected contained welds which were grossly deficient in comparison to the requirements of CSA W59 Welded Steel Construction. Then there was the "Puddle Weld", a pool of weld metal that was deposited on the ends of web members where they joined in the top chord. This non standard weld detail occurred at least at every second top chord panel point, and is depicted in the sketch below as a "Web Splice Joint".

The remainder of the panel point welds were flare bevel welds. There were also splices in the chord angles which were butt welds that were carried out using resistance welding. Another deficiency that was common through out the joist is that there was no attempt to remove the slag covering in many cases.

In light of the above it is recommended that any Robb Joists fabricated from 1963 onward using double angle chords and round rod web member, be inspected and where deemed necessary, remediated.

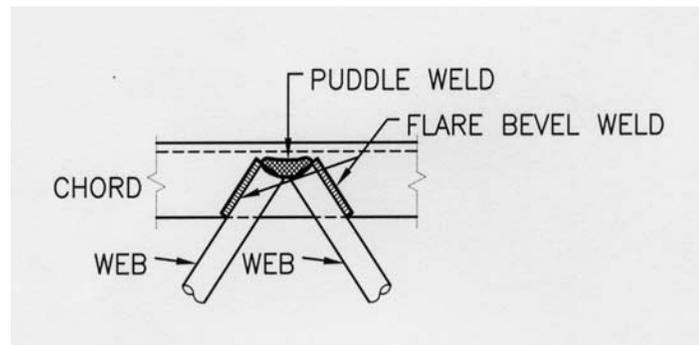
Tests carried out by Dominion Bridge Ltd. on puddle welds, indicated those welded in production were significantly lower in capacity when compared against similar welds prepared in the laboratory. It was also stated by Dominion Bridge personnel that the puddle welds were meant to be used in conjunction with flare bevel welds as indicated below. This method, however, was not normally used.
