**Report on the
Open Web Steel Joist
Remediation Program
for the Province of
Newfoundland and Labrador
VOLUME 1 - REPORT**

**The Open Web Steel Joist
Task Review Board**

**Date: March 2003
Revised: May 2005**

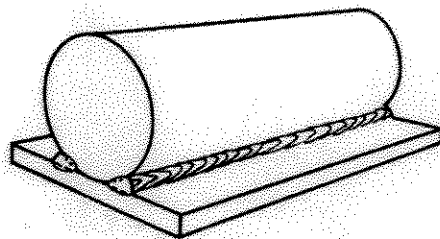
Figure 1: Flare Bevel Weld

Flare bevel welds receive special treatment by CSA W59. Because of the relative size of round solid bars with respect to the weld, the potential exists for rapid cooling which may have a quenching effect and which may in turn, promote cracking. Another issue with flare bevels is the difficulty in measuring a surface that could be confidently related to a structural capacity or effective throat. The effective throat is defined as, the minimum distance from the root of a weld to its face less any reinforcement, as shown in Figure 2 below.

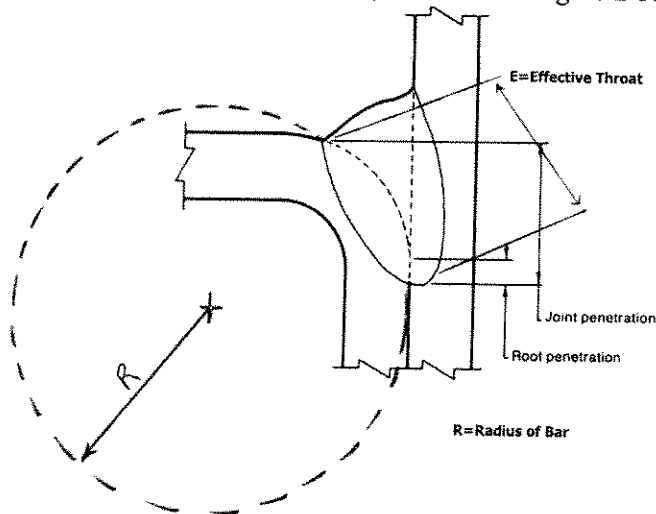
Figure 2: Flare Bevel Weld X-Section

CSA W59 required that the fabricator, through welding procedure qualification, establish the required effective throat for flare bevel welds but that in no case shall the effective throat be less than $0.25 R$ where R is the radius of the round bar.

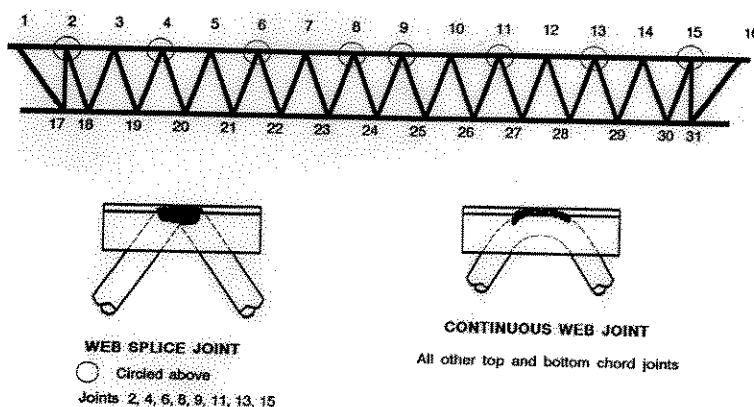
Figure 3: Puddle Weld Location

“Puddle Weld” is the term that has been very loosely applied to the weld that Robb used to weld the joint created by two (2) adjacent ends of round rod web members. Robb fabricated their web members using sections mechanically formed in the shape of a “W” or in some cases a “V”. Wherever a “V” or “W” met at the top chord a “puddle weld” was created. This is illustrated in the lefthand detail at the bottom of Figure 3 below.

The fact that the “puddle weld” was not specifically covered by the normal requirements of CSA W47.1 or CSA W59 does not mean that it could not be qualified. But it does mean that the onus was on the fabricator to demonstrate through testing that it could develop a welding procedure that would result in a consistent weld to provide the intended resistance to known stress levels. A separate set of parameters or welding procedure data sheet would be required for each set of variables such as:

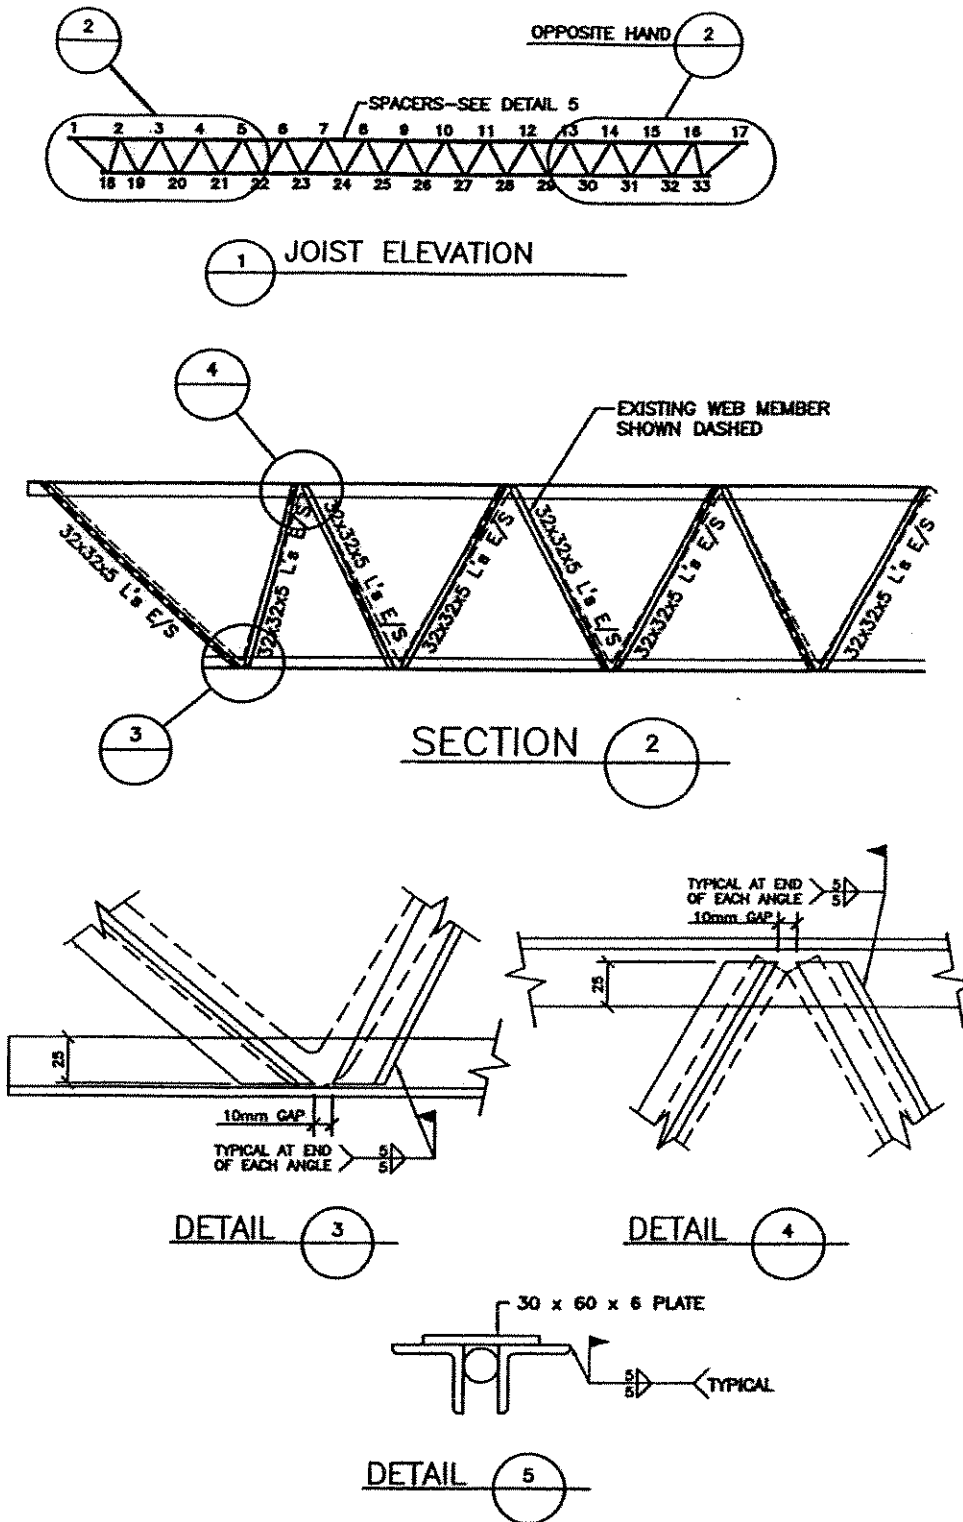
Figure 7: Level II Remediation

After one crack was induced, all joists failed above the loads for member design, but below the loads for connection design.

Considering these joists were 9.6m (31.5 ft), this series of tests provided some confidence that shorter span joists could still support loads in excess of the loads for member design even with an undetected top chord crack.

Similar to the Level I Remediation Test, the joists were first inspected and major deficiencies corrected. The web diagonals and their connections were remediated to the second bottom chord panel point, as indicated in Figure 7 on the next page. The loads were applied in the same manner as described in the previous Load I test.

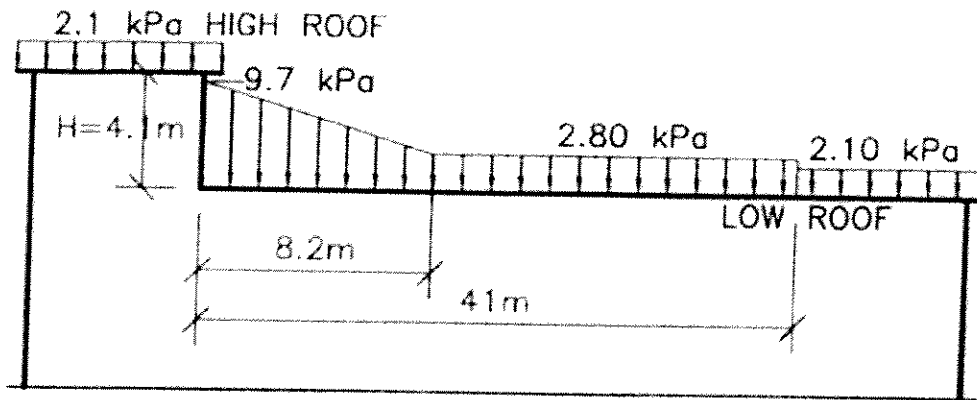
Figure 8: Jackson Walsh Snow Load Diagram Based on 1970 NBC

In the 1970's when this school extension was constructed, the basic design snow load coefficient was 0.8. Therefore, for a typical flat roof without parapets or penthouses etc. the design snow load would be 0.8 times the ground snow load. The closest place to Western Bay where meteorological information is available is St. John's. In the 1970 NBC the ground snow load was 72 PSF or 3.5 kPa which would result in a design snow load of $(3.5)(0.8) = 2.8$ kPa. For roofs that were completely exposed to wind, snow load could be reduced by a further 25% to 2.1 kPa, or 0.6 times the ground snow load. The reduction for an exposed roof could not be used for a distance from a high low roof junction equal to 10 times the roof height differential, when determining loads for the lower roof. The above can be shown schematically for Jackson Walsh School which has a roof height differential of 4.1m, as indicated in Figure 8 on the next page.

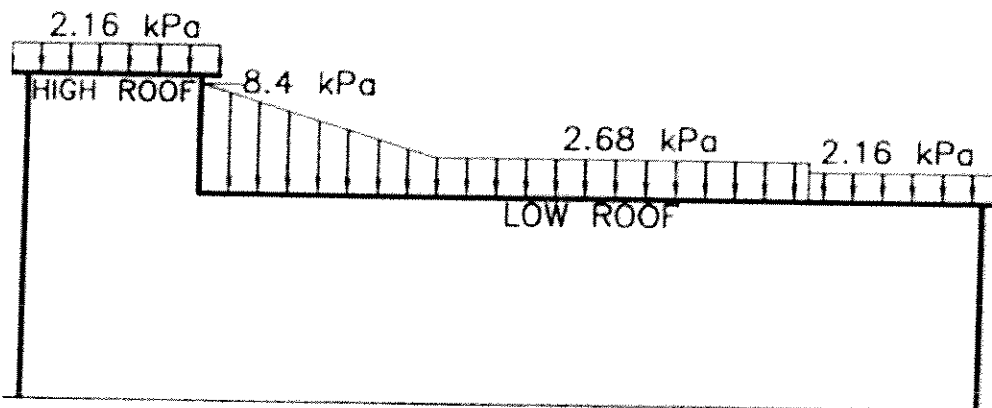
Figure 9: Jackson Walsh Snow Load Diagram Based on 1995 NBC

As can be seen on Drawing S22 in Appendix VIII, for the remediation program the designer chose to use the 1995 NBC to determine snow loads. The choice of the 1995 NBC as opposed to the 1970 NBC had very little effect on cost because the differences in load is relatively small. Furthermore, while the maximum drift load is higher for the 1995 Code (9.7 kPa v.s. 8.4 kPa) the evenly distributed loads are lower (2.68 kPa v.s. 2.8 kPa) in one area for the 1995 NBC, and only slightly higher (2.16 kPa v.s. 2.10 kPa) in other areas.

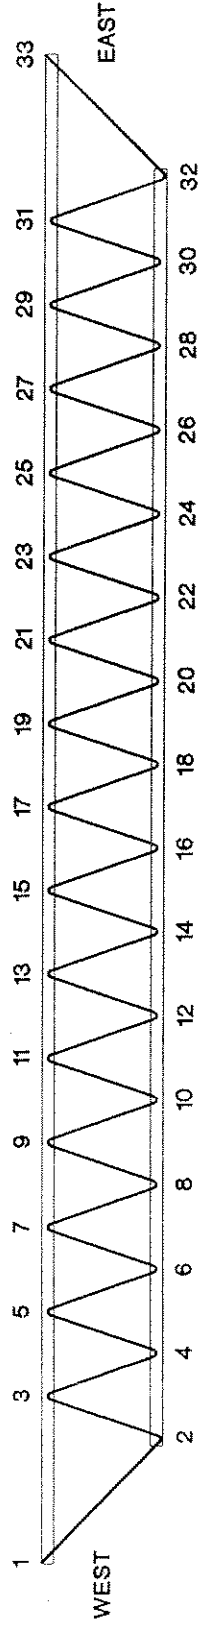
1		12	23
2	E	13	24
3	G, Puddle Weld	14	25
4	A, G	15	26
5		16	27
6	A, G	17	28
7		18	29
8		19	30
9		20	31
10		21	32
11		22	33

1. Undercut, poor profile and slag was evident throughout joists length.
2. Limited view of top chord panel points due to roof deck.
3. "Puddle welds" at discontinuous web panel points.
- 4.
- 5.
- 6.
- 7.
8. Joist inspected by M. O' Brien, P. Eng.

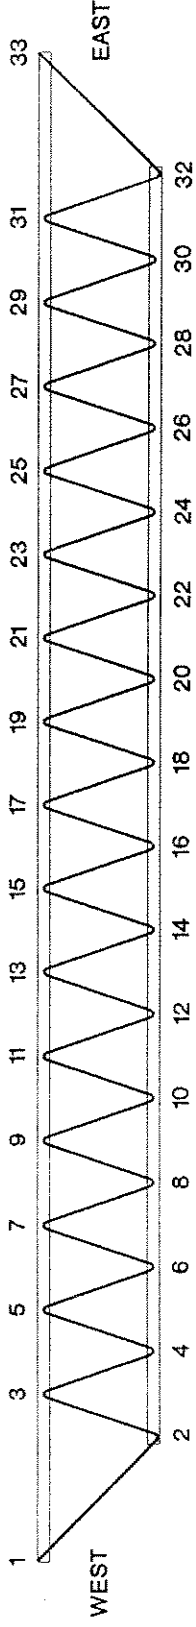
1		12	23
2	A, G	13	24
3	G, Puddle Weld	14	25
4	A, G	15	26
5		16	A, G
6	A, G	17	G
7		18	G
8		19	A, G
9		20	G, Puddle Weld
10		21	G
11		22	G
			33

- 1. Undercut, poor profile and slag was evident throughout joists length.
- 2. Limited view of top chord panel points due to roof deck.
- 3. "Puddle welds" at discontinuous web panel points.
- 4.
- 5.
- 6.
- 7.
- 8. Joist inspected by M. O' Brien, P.Eng.

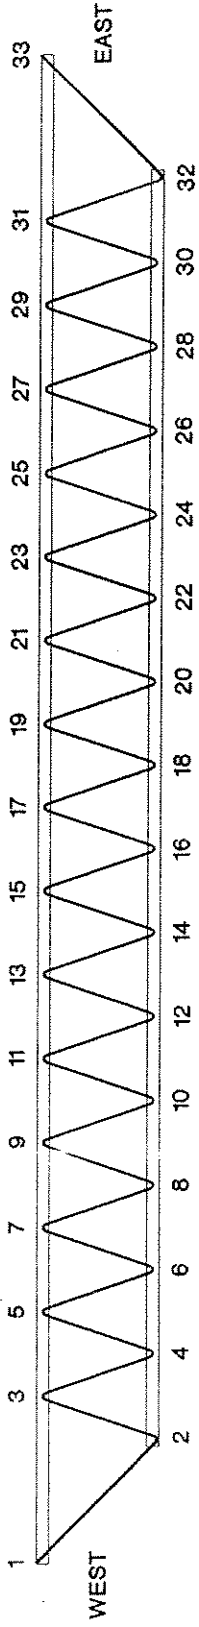
1		12	23
2	G	13	24
3	G, Puddle Weld	14	25
4	G	15	26
5		16	27
6	A, G	17	28 G
7		18	G, Puddle Weld
8		19	A, G
9		20	
10		21	G, Puddle Weld
11		22	G
			33

1. Undercut, poor profile and slag was evident throughout joists length.
2. Limited view of top chord panel points due to roof deck.
3. "Puddle welds" at discontinuous web panel points.
- 4.
- 5.
- 6.
- 7.
8. Joist inspected by M. O' Brien, P. Eng.

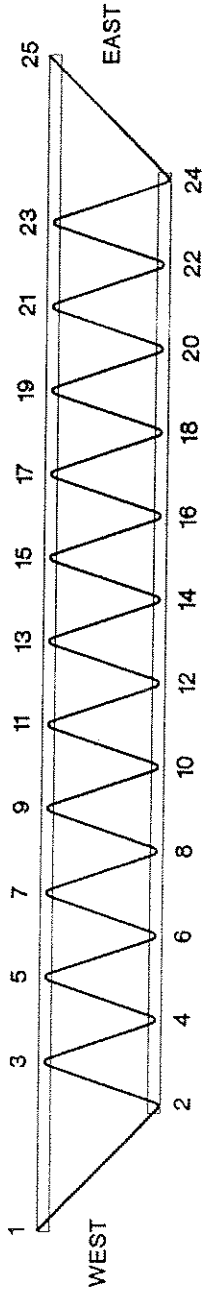
1		10	18
2	A, G	11	19
3		12	20 A, G
4	A, G	13 G, Puddle Weld	21
5	G, Puddle Weld	14 A, G	22 A, G
6	A, G	15	23 G, Puddle Weld
7		16	24 A, G
8		17	25
9

1. Undercut, poor profile and slag was evident throughout joists length.
2. Limited view of top chord panel points due to roof deck.
3. "Puddle welds" at discontinuous web panel points.
- 4.
- 5.
- 6.
- 7.
8. Joist inspected by M. O'Brien, P. Eng.

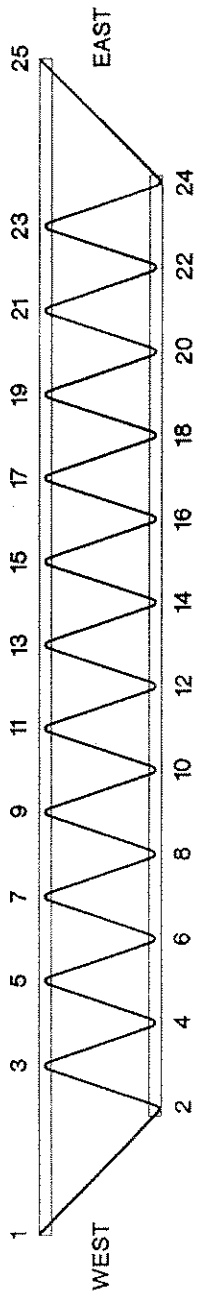
1		10	18
2	A, G	11	19
3		12	20 A, G
4	A, G	13 A, G, Puddle Weld	21
5		14	22 G, H (High)
6	G	15	23 G, Puddle Weld
7		16	24 G
8		17	25
9

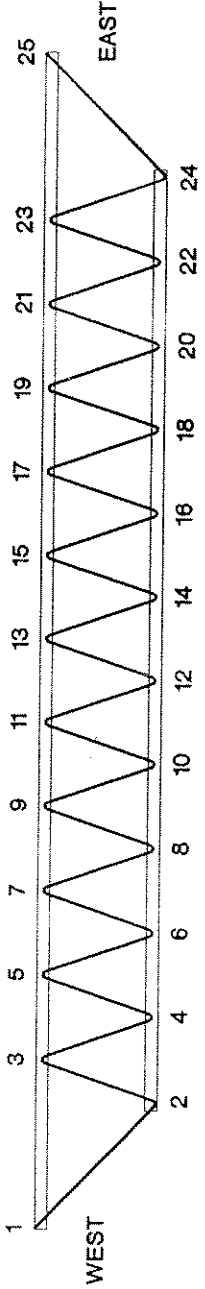
1		
2	G	
3		
4	G	
5	G, Puddle Weld	
6	A, G	
7		
8		
9		
10		18
11		19
12		20 A, G
13	G, Puddle Weld	21
14	A, G	22 G
15		23 G, Puddle Weld
16		24 G
17		25

1. Undercut, poor profile and slag was evident throughout joists length.
2. Limited view of top chord panel points due to roof deck.
3. "Puddle welds" at discontinuous web panel points.
- 4.
- 5.
- 6.
- 7.
8. Joist inspected by M. O'Brien, P.Eng.

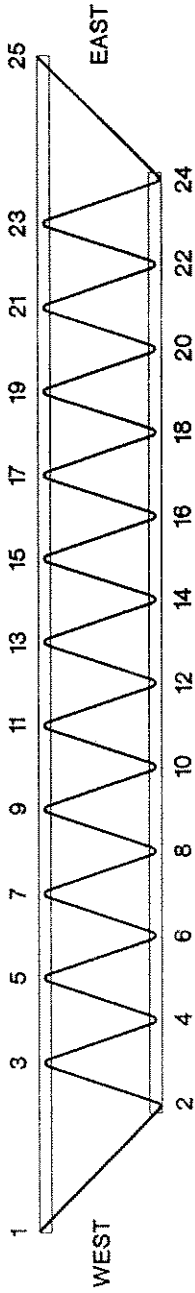
1		10	18
2	G	11	19
3		12	A, G
4	A, G	13	G, Puddle Weld
5		14	
6	G	15	
7		16	
8		17	
9

1. Undercut, poor profile and slag was evident throughout joists length.
2. Limited view of top chord panel points due to roof deck.
3. "Puddle welds" at discontinuous web panel points.
- 4.
- 5.
- 6.
- 7.
8. Joist inspected by M. O'Brien, P. Eng.

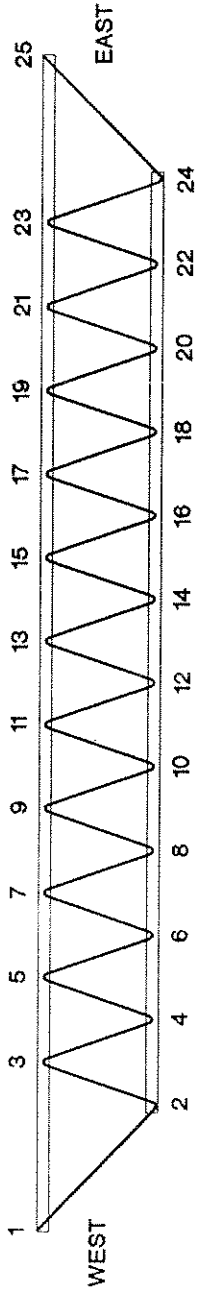
1		10	18
2	G	11	19
3		12	20 A, G
4	A, G	13	21
5	A, G, Puddle Weld	14	22 A, G
6	G	15	23 G, Puddle Weld
7		16	24 A, G
8		17	25
9

1. Undercut, poor profile and slag was evident throughout joists length.
2. Limited view of top chord panel points due to roof deck.
3. "Puddle welds" at discontinuous web panel points.
- 4.
- 5.
- 6.
- 7.
8. Joist inspected by M. O'Brien, P.Eng.

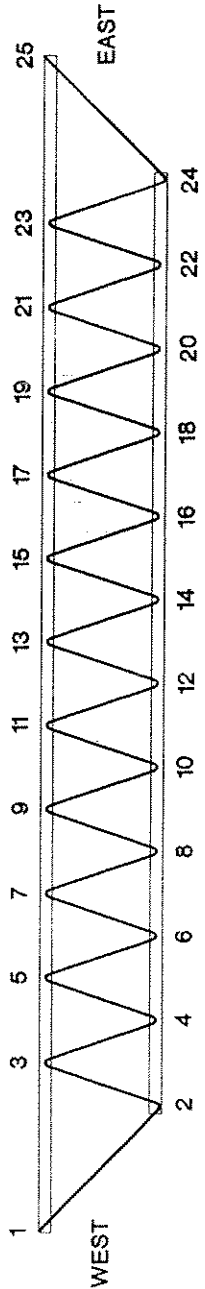
1		10	18
2	A, G	11	19
3		12 A, G	20 G
4	A, G	13 G, Puddle Weld	21
5	G, Puddle Weld	14	22 G
6	A, G	15	23 A, G, Puddle Weld
7		16	24 G
8		17	25
9

1. Undercut, poor profile and slag was evident throughout joists length.
2. Limited view of top chord panel points due to roof deck.
3. "Puddle welds" at discontinuous web panel points.
- 4.
- 5.
- 6.
- 7.
8. Joist inspected by M. O'Brien, P.Eng.

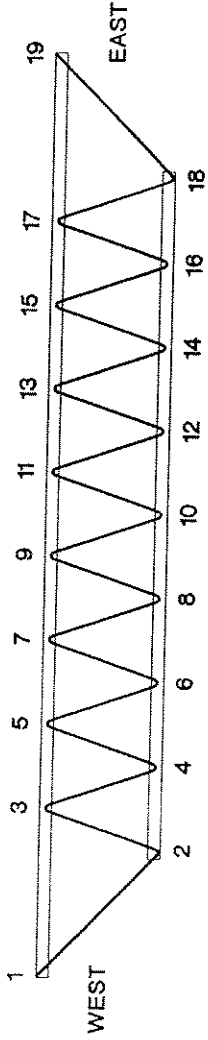
1		
2	A, G	14
3	A, G, Puddle Weld	15
4	G, H (Low)	16 A, G
5		17 G, Puddle Weld
6		18 A, G, H (High)
7		19
8		
9	A, G, Puddle Weld	
10		
11		
12		
13

1. Undercut, poor profile and slag was evident throughout joists length.
2. Limited view of top chord panel points due to roof deck.
3. "Puddle welds" at discontinuous web panel points.
- 4.
- 5.
- 6.
- 7.
8. Joist inspected by M. O'Brien, P. Eng.

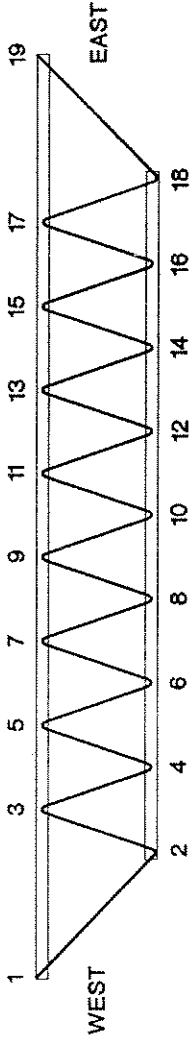
1			
2	A, G		14
3	A, G, Puddle Weld		15
4	G		16 G
5			17 G, Puddle Weld
6			18 A, G, H (High)
7			19

1. Undercut, poor profile and slag was evident throughout joists length.
2. Limited view of top chord panel points due to roof deck.
3. "Puddle welds" at discontinuous web panel points.
- 4.
- 5.
- 6.
- 7.
8. Joist inspected by M. O'Brien, P.Eng.

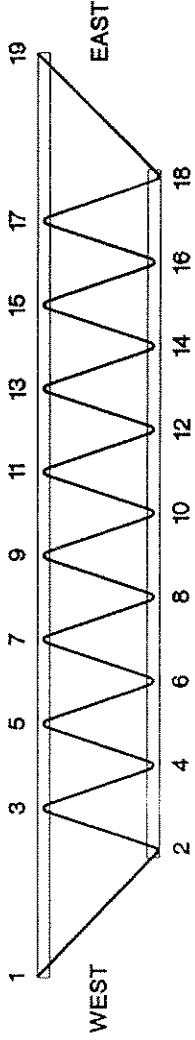
1		
2	A, G	
3	A, G, Puddle Weld	
4	A, G	
5		
6		
7		
8		14
9	G, Puddle Weld	15
10		16 G
11		17 G, Puddle Weld
12		18 A, G
13		19

- 1. Undercut, poor profile and slag was evident throughout joists length.
- 2. Limited view of top chord panel points due to roof deck.
- 3. "Puddle welds" at discontinuous web panel points.
- 4.
- 5.
- 6.
- 7.
- 8. Joist inspected by M. O'Brien, P.Eng.

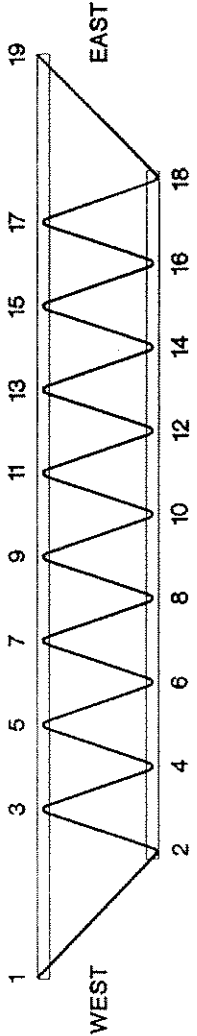
1			
2	A, G		14
3	A, G, Puddle Weld		15
4	A, G		16 G
5			17 G, Puddle Weld
6			18 A, G
7			19
8			
9	G, Puddle Weld		
10			
11			
12			
13

1. Undercut, poor profile and slag was evident throughout joists length.
2. Limited view of top chord panel points due to roof deck.
3. "Puddle welds" at discontinuous web panel points.
- 4.
- 5.
- 6.
- 7.
8. Joist inspected by M. O'Brien, P.Eng.

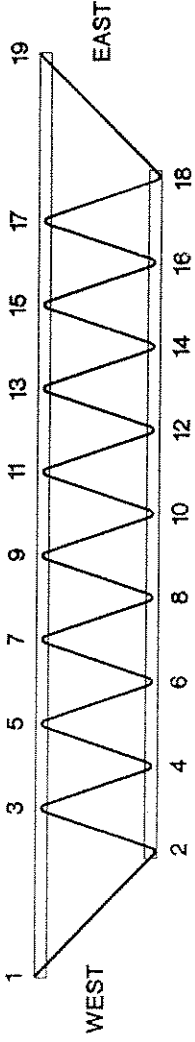
1		8	14
2	A, G	9 G, Puddle Weld	15
3	A, G, Puddle Weld	10	16 G
4	G	11	17 G, Puddle Weld
5		12	18 A, G, H (High)
6		13	19
7

1. Undercut, poor profile and slag was evident throughout joists length.
2. Limited view of top chord panel points due to roof deck.
3. "Puddle welds" at discontinuous web panel points.
- 4.
- 5.
- 6.
- 7.
8. Joist inspected by M. O'Brien, P. Eng.

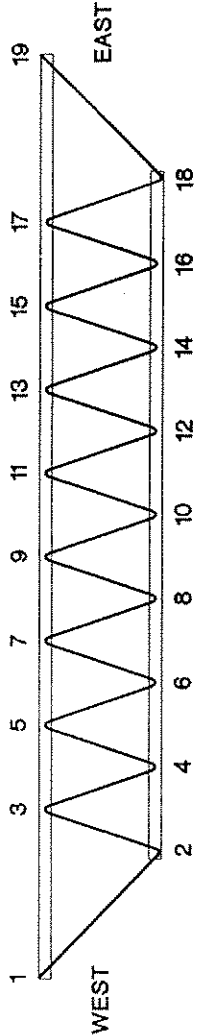
1		8	14
2	A, G	9 G, Puddle Weld	15
3	A, G, Puddle Weld	10	16 G
4	G, H (Low)	11	17 G, Puddle Weld
5		12	18 A, G
6		13	19
7

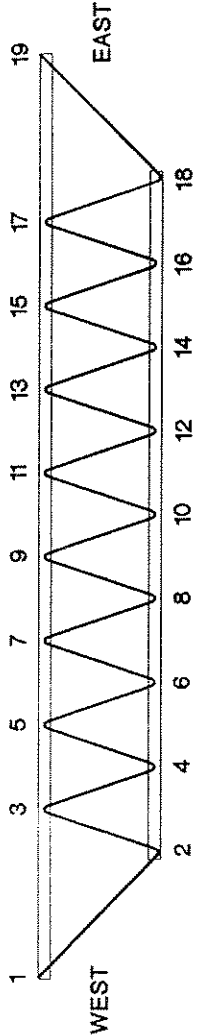
1		
2	G	
3	G, Puddle Weld	
4	A, G	
5		
6		
7		
8		14
9	G, Puddle Weld	15
10		16 G
11		17 G, Puddle Weld
12		18 A, G
13		19

- 1. Undercut, poor profile and slag was evident throughout joists length.
- 2. Limited view of top chord panel points due to roof deck.
- 3. "Puddle welds" at discontinuous web panel points.
- 4.
- 5.
- 6.
- 7.
- 8. Joist inspected by M. O'Brien, P.Eng.

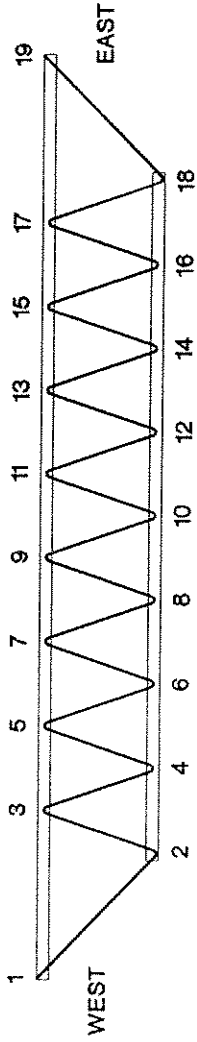
1		
2	A, G	
3	A, G, Puddle Weld	
4	G, H (Low)	
5		
6		
7		
8		14
9	A, G, Puddle Weld	15
10		16 A, G
11		17 G, Puddle Weld
12		18 A, G, H (High)
13		19

1. Undercut, poor profile and slag was evident throughout joists length.
2. Limited view of top chord panel points due to roof deck.
3. "Puddle welds" at discontinuous web panel points.
- 4.
- 5.
- 6.
- 7.
8. Joist inspected by M. O'Brien, P. Eng.

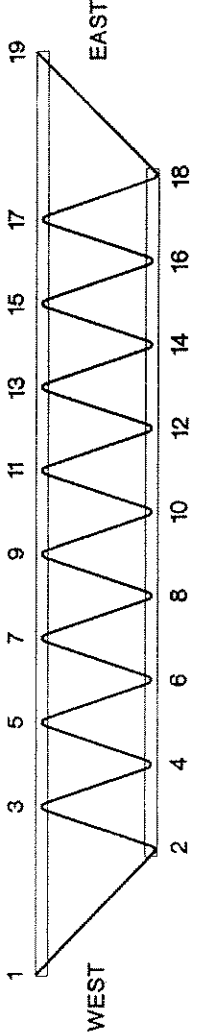
1		8	14
2	A, G	9 G, Puddle Weld	15
3	A, G, Puddle Weld	10	16 G
4	A, G	11	17 G, Puddle Weld
5		12	18 A, G
6		13	19
7

1. Undercut, poor profile and slag was evident throughout joists length.
2. Limited view of top chord panel points due to roof deck.
3. "Puddle welds" at discontinuous web panel points.
- 4.
- 5.
- 6.
- 7.
8. Joist inspected by M. O'Brien, P.Eng.

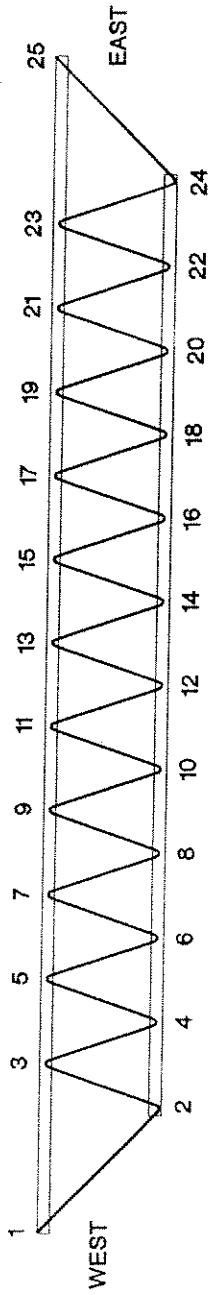
1		10	18
2	G	11	19
3	G, Puddle Weld	12	20
4	G	13	21
5		14	22 A, G
6		15	23 G, Puddle Weld
7		16	24 G
8		17	25
9

1. Undercut, poor profile and slag was evident throughout joists length.
2. Limited view of top chord panel points due to roof deck.
3. "Puddle welds" at discontinuous web panel points.
- 4.
- 5.
- 6.
- 7.
8. Joist inspected by M. O'Brien, P.Eng.

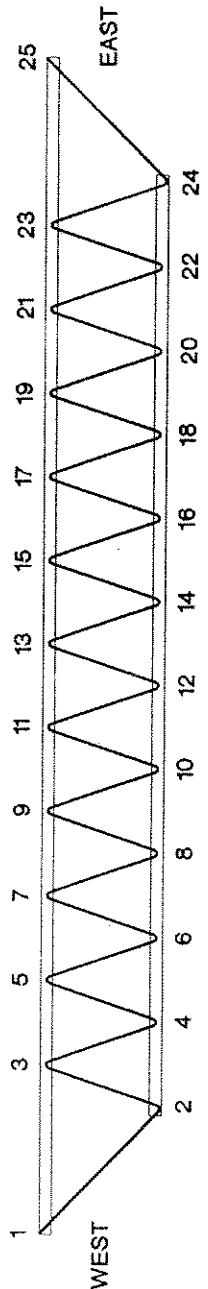
1		10	18
2	A, B, G	11	19
3	G, Puddle Weld	12	20
4	A, G, H (High)	13	21
5	G, Puddle Weld	14	22 A, G, H (High)
6		15	23 G, Puddle Weld
7		16	24 A, B, G
8		17	25
9

1. Undercut, poor profile and slag was evident throughout joists length.
2. Limited view of top chord panel points due to roof deck.
3. "Puddle welds" at discontinuous web panel points.
- 4.
- 5.
- 6.
- 7.
8. Joist inspected by M. O'Brien, P.Eng.

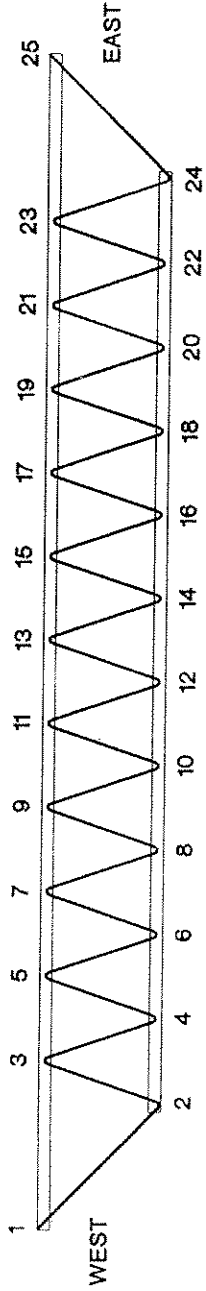
1		10	18
2	A, G	11	19
3		12	20
4	A, G	13	21 G, Puddle Weld
5		14	22 A, G
6	A, G	15	23 G, Puddle Weld
7		16	24 A, G
8		17	25
9

1. Undercut, poor profile and slag was evident throughout joists length.
2. Limited view of top chord panel points due to roof deck.
3. "Puddle welds" at discontinuous web panel points.
- 4.
- 5.
- 6.
- 7.
8. Joist inspected by M. O'Brien, P. Eng.

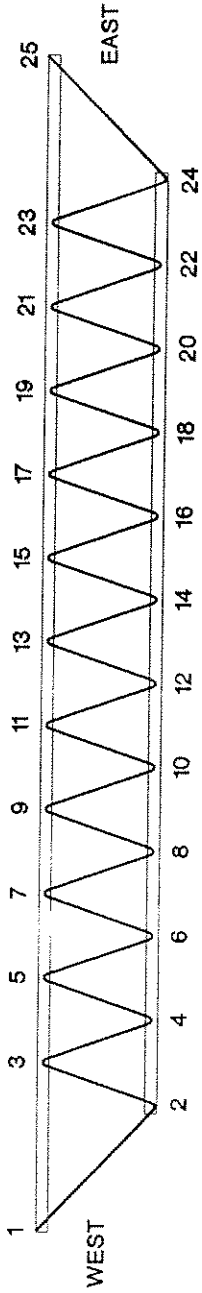
1		10	18
2	G	11	19
3		12	20 A, G
4	A, G	13 G, Puddle Weld	21
5	A, G, Puddle Weld	14 A, G	22 A, G
6	G	15	23 G, Puddle Weld
7		16	24 A, G
8		17	25
9

1. Undercut, poor profile and slag was evident throughout joists length.
2. Limited view of top chord panel points due to roof deck.
3. "Puddle welds" at discontinuous web panel points.
- 4.
- 5.
- 6.
- 7.
8. Joist inspected by M. O'Brien, P.Eng.

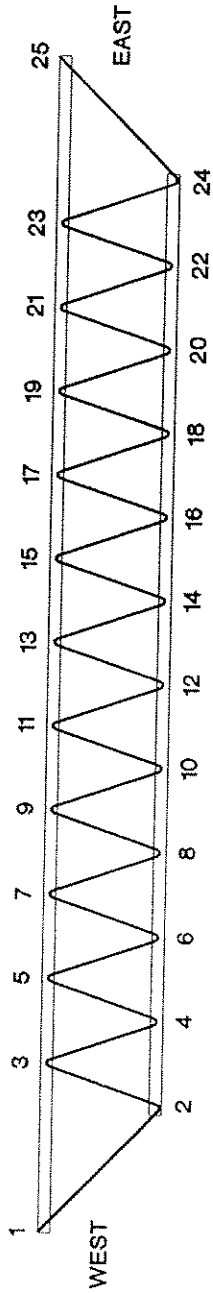
1		
2	G	18
3		19
4	G	20
5	G, Puddle Weld	21
6	A, G	22 G
7		23 G, Puddle Weld
8		24 G
9		25

1. Undercut, poor profile and slag was evident throughout joists length.
2. Limited view of top chord panel points due to roof deck.
3. "Puddle welds" at discontinuous web panel points.
- 4.
- 5.
- 6.
- 7.
8. Joist inspected by M. O'Brien, P.Eng.

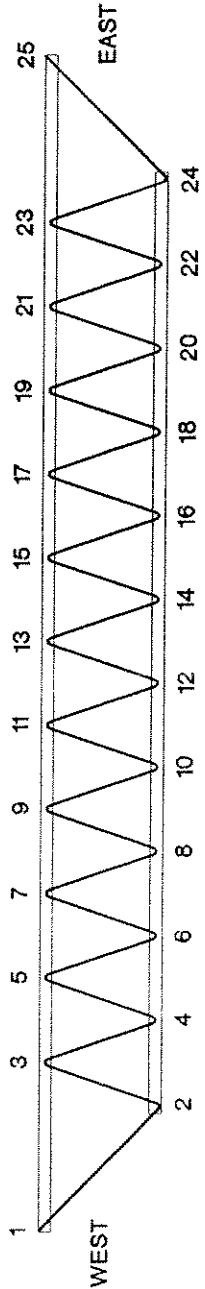
1		10	18
2	A, G	11	19
3		12	20
4	A, G	13	21
5	G, Puddle Weld	14	22 A, G
6	A, G	15	23 G, Puddle Weld
7		16	24 G
8		17	25
9

1. Undercut, poor profile and slag was evident throughout joists length.
2. Limited view of top chord panel points due to roof deck.
3. "Puddle welds" at discontinuous web panel points.
- 4.
- 5.
- 6.
- 7.
8. Joist inspected by M. O'Brien, P.Eng.

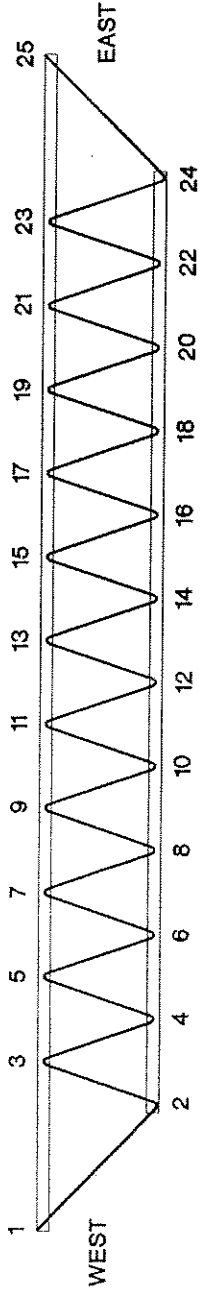
1		10	18
2	A, G	11	19
3		12	20 A, G
4	A, G	13 A, G, Puddle Weld	21
5		14	22 G, H (High)
6	G	15	23 G, Puddle Weld
7		16	24 G
8		17	25
9

1. Undercut, poor profile and slag was evident throughout joists length.
2. Limited view of top chord panel points due to roof deck.
3. "Puddle welds" at discontinuous web panel points.
- 4.
- 5.
- 6.
- 7.
8. Joist inspected by M. O'Brien, P. Eng.

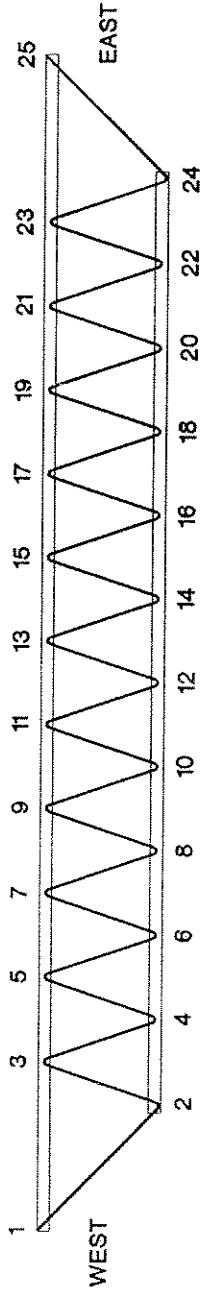
1		10	18
2	A, G	11	19
3		12	A, G
4	A, G	13	A, G, Puddle Weld
5	G, Puddle Weld	14	
6	A, G	15	
7		16	
8		17	24 G
9			25

1. Undercut, poor profile and slag was evident throughout joists length.
2. Limited view of top chord panel points due to roof deck.
3. "Puddle welds" at discontinuous web panel points.
- 4.
- 5.
- 6.
- 7.
8. Joist inspected by M. O'Brien, P.Eng.

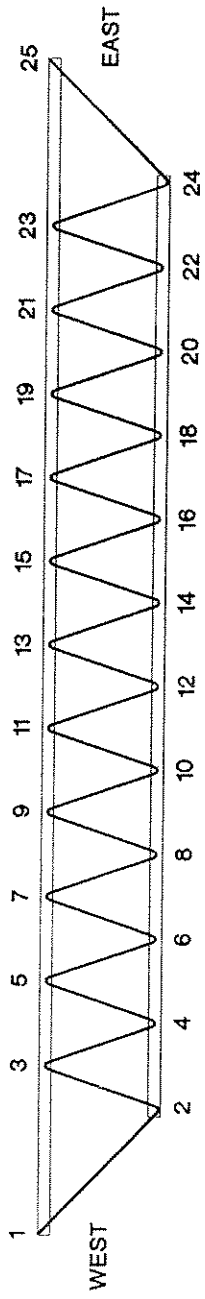
1		10	18
2	A, G	11	19
3	G, Puddle Weld	12	20
4	A, G, H (Low)	13 G, Puddle Weld	21
5		14 A, G	22 A, G
6	A, G	15	23 A, G, Puddle Weld
7		16	24 G
8		17	25
9

1. Undercut, poor profile and slag was evident throughout joists length.
2. Limited view of top chord panel points due to roof deck.
3. "Puddle welds" at discontinuous web panel points.
- 4.
- 5.
- 6.
- 7.
8. Joist inspected by M. O'Brien, P. Eng.

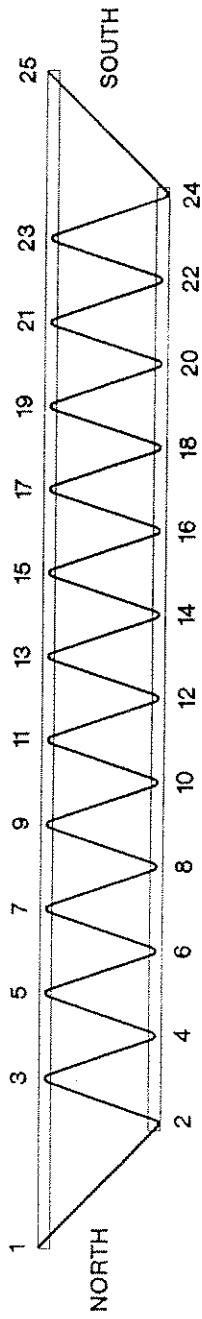
1		10	18
2	A, G	11	19
3		12	20 A, G
4	A, G	13 G, Puddle Weld	21 G, Puddle Weld
5	G, Puddle Weld	14	22 G
6	A, G	15	23
7		16	24 G
8		17	25
9

1. Undercut, poor profile and slag was evident throughout joists length.
2. Limited view of top chord panel points due to roof deck.
3. "Puddle welds" at discontinuous web panel points.
- 4.
- 5.
- 6.
- 7.
8. Joist inspected by M. O'Brien, P.Eng.

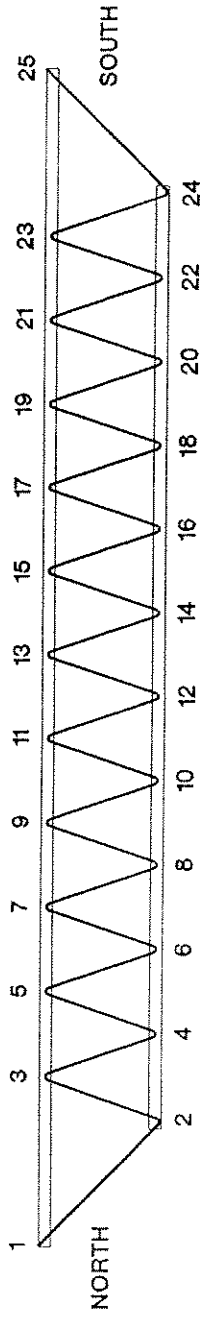
1		10	18
2	G	11	19
3	G, Puddle Weld	12	20 A, G
4	A, G	13 G, Puddle Weld	21
5		14 A, G	22 A, G
6	A, G	15	23 G, Puddle Weld
7		16	24 A, G
8		17	25
9

1. Undercut, poor profile and slag was evident throughout joists length.
2. Limited view of top chord panel points due to roof deck.
3. "Puddle welds" at discontinuous web panel points.
- 4.
- 5.
- 6.
- 7.
8. Joist inspected by M. O'Brien, P.Eng.

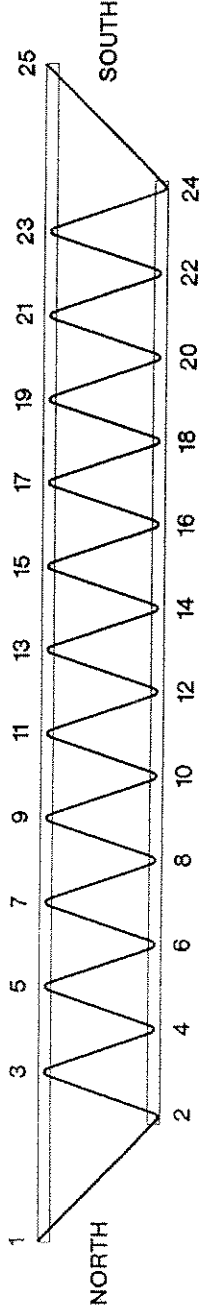
1		10	18
2	G	11	19
3	A, G, Puddle Weld	12	G
4	G, H (High)	13	G, Puddle Weld
5		14	G
6	G	15	
7		16	A, G, Puddle Weld
8		17	G
9			25

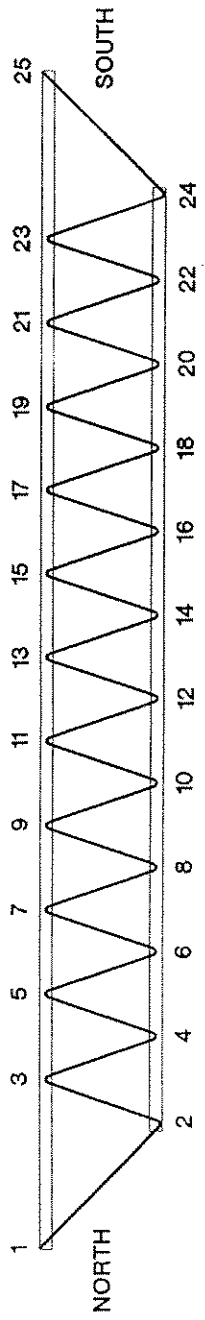
1		10	18
2	A, G	11	19
3	G, Puddle Weld	12	20 A, G
4	A, G	13	21
5	G, Puddle Weld	14	22 A, G
6	A, G	15	23 G, Puddle Weld
7		16	24 A, G
8		17	25
9

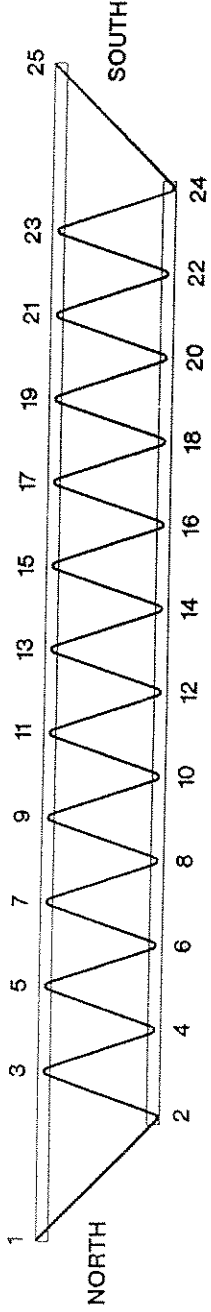
1		
2	A, G	18
3	G, Puddle Weld	19
4	A, G, H (Low)	20 A, G
5		21
6	A, G	22 A, G
7		23 A, G, Puddle Weld
8		24 G
9		25

1. Undercut, poor profile and slag was evident throughout joists length.
2. Limited view of top chord panel points due to roof deck.
3. "Puddle welds" at discontinuous web panel points.
- 4.
- 5.
- 6.
- 7.
8. Joist inspected by M. O'Brien, P. Eng.

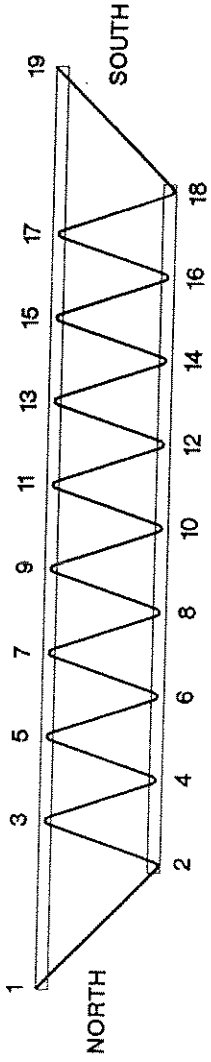
1		
2	G	
3		
4	A, G	
5	G	
6		
7		
8		A, G, H (Low)
9	A, G, Puddle Weld	
10		
11		
12		G, Puddle Weld
13		A, G
14		
15		
16		
17		
18		
19

1. Undercut, poor profile and slag was evident throughout joists length.
2. Limited view of top chord panel points due to roof deck.
3. "Puddle welds" at discontinuous web panel points.
- 4.
- 5.
- 6.
- 7.
8. Joist inspected by M. O'Brien, P. Eng.

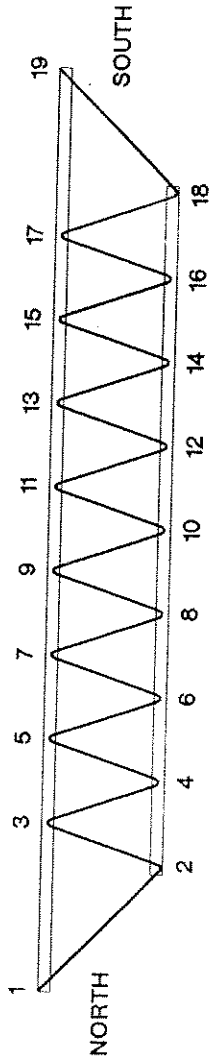
1		
2	G	14
3		15
4	G, H (Low)	16 G
5	A, G, Puddle Weld	17 G, Puddle Weld
6		18 G
7		19
8		
9	G	
10		
11		
12		
13

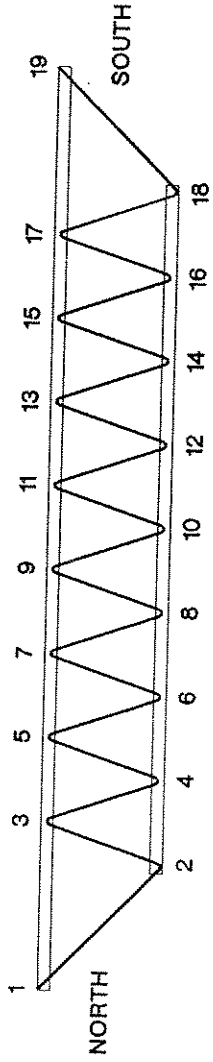
1		8	
2	A, G	9	A, G
3		10	
4	G	11	
5	G, Puddle Weld	12	
6		13	
7			
		14	
		15	
		16	A, G, H (Low)
		17	G, Puddle Weld
		18	G, H (High)
		19

1. Undercut, poor profile and slag was evident throughout joists length.
2. Limited view of top chord panel points due to roof deck.
3. "Puddle welds" at discontinuous web panel points.
4. Web member slightly bent between panel points 15 and 16.
5. Bottom chord angles misaligned approximately 8 mm.
- 6.
- 7.
8. Joist inspected by M. O'Brien, P. Eng.

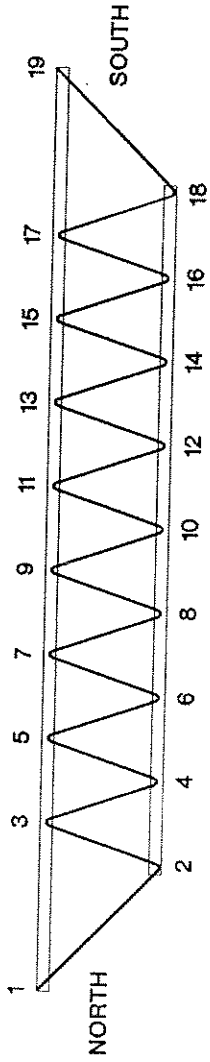
1		
2	G	
3		
4	G	
5		
6	A, G, H (Low)	
7		
8		14 A, G
9	A, G, Puddle Weld	15
10		16 A, G
11		17 G, Puddle Weld
12		18 A, G, H (High)
13		19

1. Undercut, poor profile and slag was evident throughout joists length.
2. Limited view of top chord panel points due to roof deck.
3. "Puddle welds" at discontinuous web panel points.
- 4.
- 5.
- 6.
- 7.
8. Joist inspected by M. O'Brien, P.Eng.

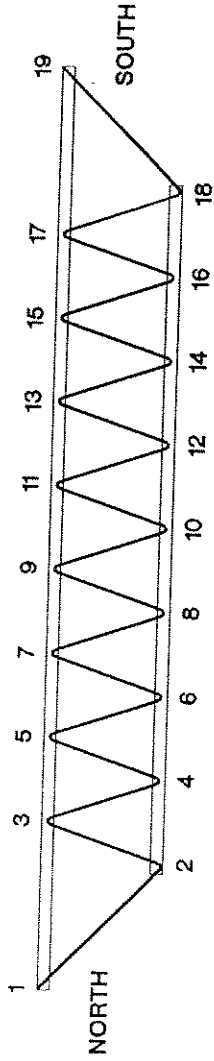
1			
2	G		
3			
4	A, G, H (Low)		
5			
6			
7			
8			
9	A, G, Puddle Weld		14
10			15 A, G
11			16 G, F, H (Low)
12			17
13			18 A, G
			19

1. Undercut, poor profile and slag was evident throughout joists length.
2. Limited view of top chord panel points due to roof deck.
3. "Puddle welds" at discontinuous web panel points.
- 4.
- 5.
- 6.
- 7.
8. Joist inspected by M. O'Brien, P. Eng.

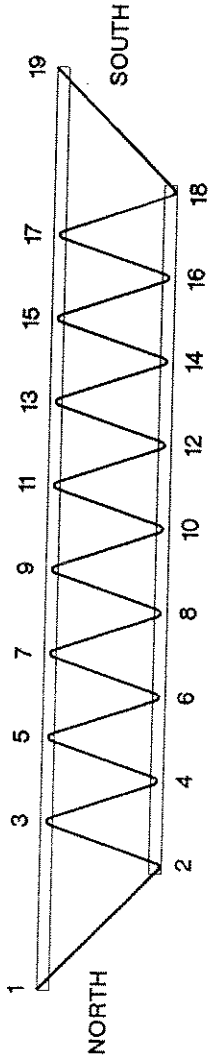
1			
2	G, H (High)		14
3			15
4	A, G		16 G, H (Low)
5	A, G		17 G, Puddle Weld
6			18 G
7			19
8			
9	G, Puddle Weld		
10			
11			
12			
13

1. Undercut, poor profile and slag was evident throughout joists length.
2. Limited view of top chord panel points due to roof deck.
3. "Puddle welds" at discontinuous web panel points.
- 4.
- 5.
- 6.
- 7.
8. Joist inspected by M. O'Brien, P.Eng.

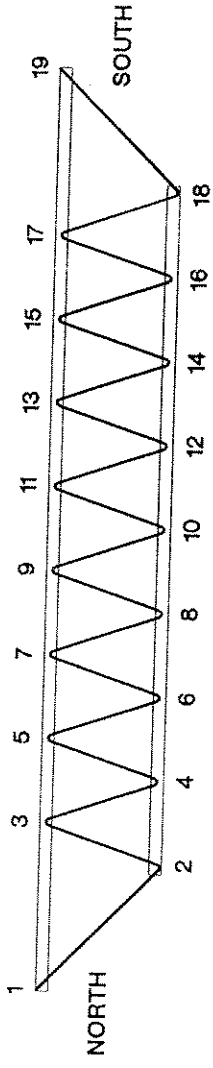
1		
2	A, G	8
3	A, G, Puddle Weld	9 A, G, Puddle Weld
4	G, H (Low)	10
5		11
6		12
7		13
		14
		15 G
		16 A, G, H (Low)
		17 G, H (High)
		18
		19

1. Undercut, poor profile and slag was evident throughout joists length.
2. Limited view of top chord panel points due to roof deck.
3. "Puddle welds" at discontinuous web panel points.
- 4.
- 5.
- 6.
- 7.
8. Joist inspected by M. O'Brien, P.Eng.

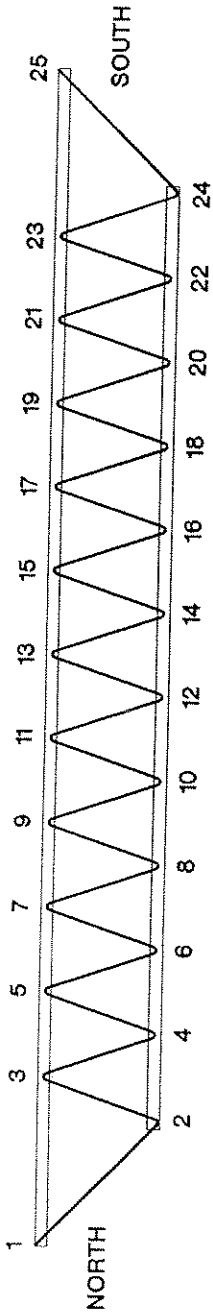
1		10	18
2	A, G	11	19
3		12	A, G, H (Low)
4	A, G	13	A, G, Puddle Weld
5	G, Puddle Weld	14	
6	A, G	15	
7		16	
8		17	24 G
9			25

1. Undercut, poor profile and slag was evident throughout joists length.
2. Limited view of top chord panel points due to roof deck.
3. "Puddle welds" at discontinuous web panel points.
- 4.
- 5.
- 6.
- 7.
8. Joist inspected by M. O'Brien, P.Eng.

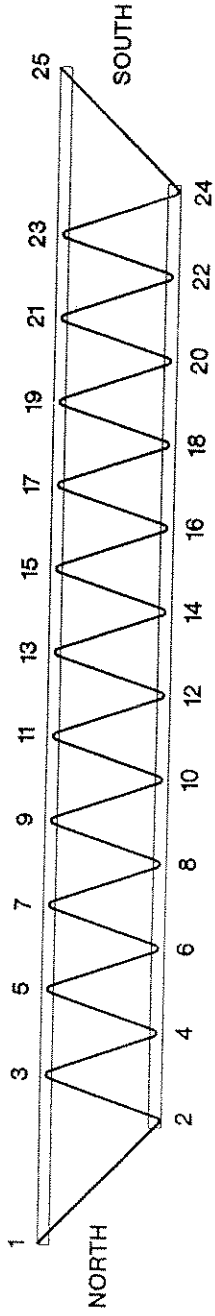
1		
2	G	18
3	G, Puddle Weld	19
4	A, G	20 A, F, G
5		21
6	G	22 A, G
7		23 G, Puddle Weld
8		24 A, G
9		25

1. Undercut, poor profile and slag was evident throughout joists length.
2. Limited view of top chord panel points due to roof deck.
3. "Puddle welds" at discontinuous web panel points.
- 4.
- 5.
- 6.
- 7.
8. Joist inspected by M. O'Brien, P.Eng.

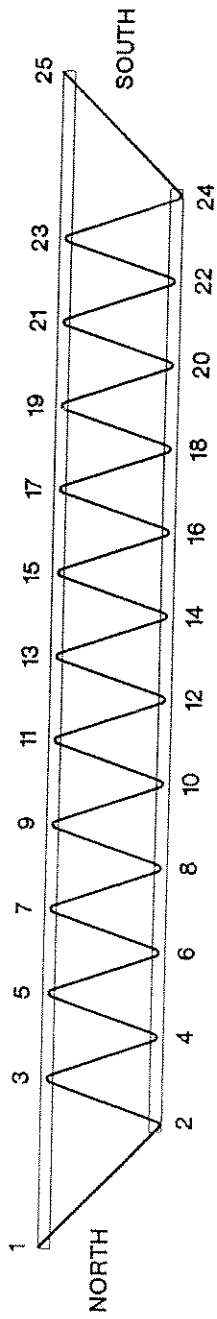
1		
2	G	18
3		19
4	A, G, H (High)	20 G
5		21
6	A, G, H (Low)	22 G
7		23 G, Puddle Weld
8		24 A, G
9		25

1. Undercut, poor profile and slag was evident throughout joists length.
2. Limited view of top chord panel points due to roof deck.
3. "Puddle welds" at discontinuous web panel points.
- 4.
- 5.
- 6.
- 7.
8. Joist inspected by M. O'Brien, P.Eng.

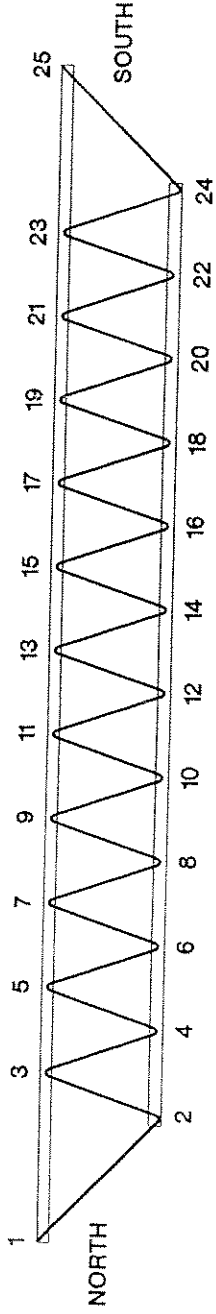
1		
2	A, G	18
3	G, Puddle Weld	19
4	A, G	20 F, G
5		21
6	A, G	22 F, G
7		23 G, Puddle Weld
8		24 A, G
9		25

1. Undercut, poor profile and slag was evident throughout joists length.
2. Limited view of top chord panel points due to roof deck.
3. "Puddle welds" at discontinuous web panel points.
- 4.
- 5.
- 6.
- 7.
8. Joist inspected by M. O'Brien, P.Eng.

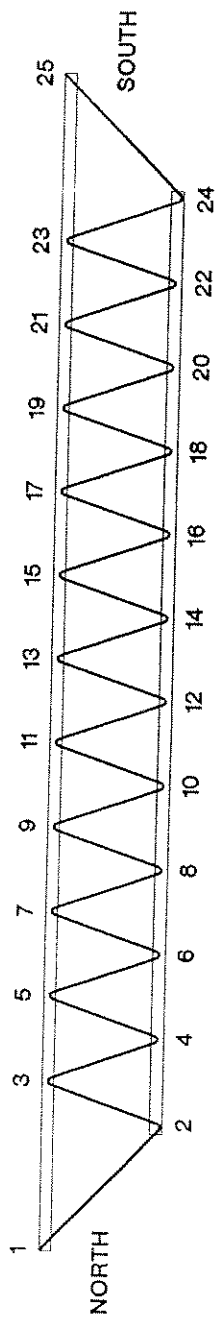
1		
2	G	18
3		19
4	G	20 A, G
5	G, Puddle Weld	21 G, Puddle Weld
6	G	22 A, G
7		23
8		24 A, G, H (High)
9		25

1. Undercut, poor profile and slag was evident throughout joists length.
2. Limited view of top chord panel points due to roof deck.
3. "Puddle welds" at discontinuous web panel points.
- 4.
- 5.
- 6.
- 7.
8. Joist inspected by M. O'Brien, P.Eng.

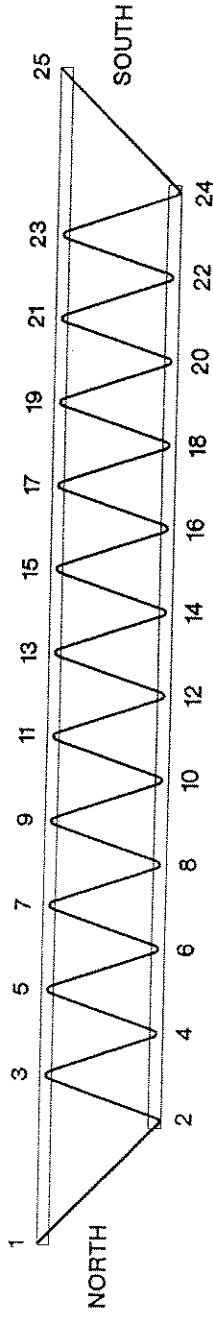
1		
2	A, G	18
3	G, Puddle Weld	19
4	A, G	20 G
5		21
6	G	22 G
7		23 A, G, Puddle Weld
8		24 A, G
9		25

1. Undercut, poor profile and slag was evident throughout joists length.
2. Limited view of top chord panel points due to roof deck.
3. "Puddle welds" at discontinuous web panel points.
- 4.
- 5.
- 6.
- 7.
8. Joist inspected by M. O'Brien, P. Eng.

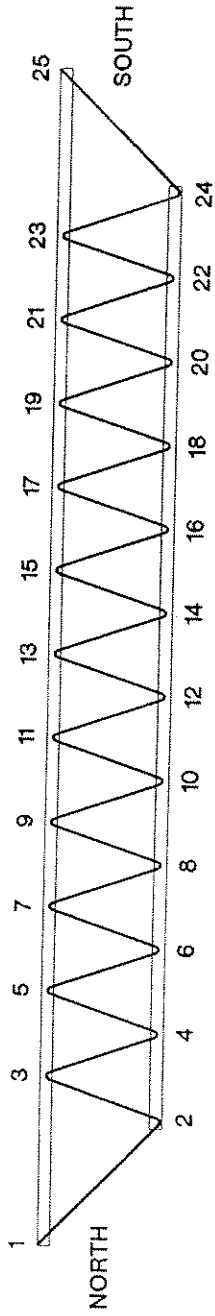
1		
2	G	18
3	G, Puddle Weld	19
4	G	20 A, G
5		21 G, Puddle Weld
6	G	22 A, G
7		23 G
8		24 A, G
9		25
