ENGINEERING HISTORY PAPER #112

“The Story of Grand Bay Bridge and its Demise”

THE STORY OF GRAND BAY BRIDGE AND ITS DEMISE

By: Philip Helwig, M.Sc. (Hydraulics), P.Eng. (Retired), St. John's (NL), September 12, 2023

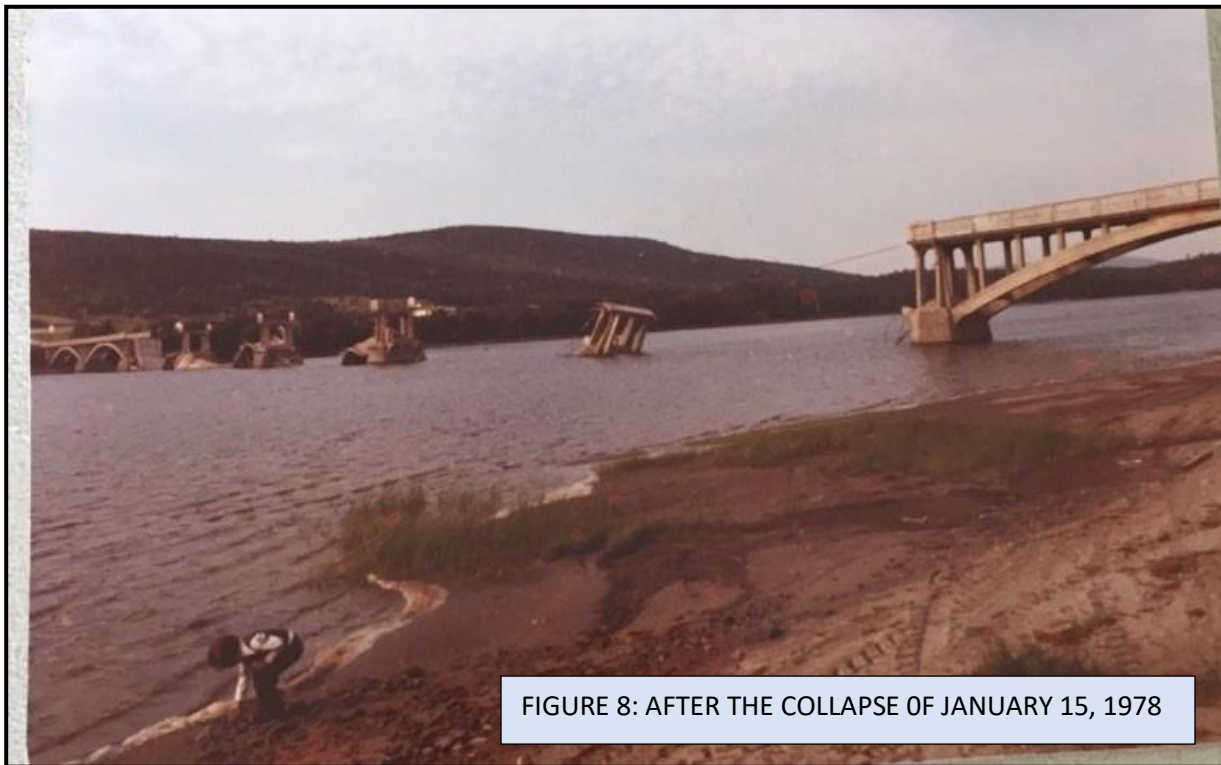
Usually, breakup of the Grand Codroy River Estuary occurs passively by ice melting in place. Exceptionally, in about 1 in 5 years, breakup up is dynamic and produces an ice run as river ice is flushed downstream. This phenomenon is produced when breakup is triggered by the combination of high flows with intact ice covers. A particularly dynamic breakup occurred in January 1978, due to an unseasonable warm spell accompanied by heavy rains, starting on January 14th or thereabouts. This unseasonable rain storm came after an extended period of very cold weather. Based on the degree-days of freezing for the 1977/78 winter to that date, I estimated the ice thickness would have been 0.3 m (1.0'). The resulting flood peak which occurred on January 15 was estimated to have been about 807 m³/s (28,500 ft³/s) - equivalent to a 1 in 10-year flood event. Descriptions of previous dynamic breakups noted that ice was usually cleared through a channel near the north bank, this channel was uncharacteristically blocked with ice in 1978 (exceptionally big ice floes observed in the river that year and above average ice strength and thickness may have contributed to this blockage). Meanwhile another channel opened near the south bank diverting much of river flow into this channel. Department of High Roads officials were aware that Pier 6, second pier from the south bank, was vulnerable having suffered significant damage due to scouring over the years. The resulting high flow velocities in the south channel likely aggravated this situation leading to the undermining and destabilization of Pier 6 which led to a domino type failure of the five central spans of the bridge. Ice impact loads may also have been a factor in the initial failure of Pier 6. Figure 8 shows the conditions after collapse of the Bridge.

The Department of Transportation and Communications constructed a temporary bridge, at the Gut, to provide access to communities on the north bank of Great Codroy River that was ready for traffic in April 1978 and is still in use today, see Figure 8.

At about 4:30 pm on January 15, 1978, two teenage girls were returning from basketball practice in the school gym at Upper Ferry. They were part way across the bridge when the bridge started to collapse under their heels. They ran as fast as they could ahead of the collapsing bridge. I dare say they would have set the Newfoundland sprint record for girls, had someone been there with a stop watch to record their sprint! Thankfully, they reached the north shore safely. Saint Theresa had intervened just in the nick of time. The collapse started with the scouring of Pier 6, second from the south abutment, which triggered a cascading failure resulting in five of eight spans falling into the river. Only one span on the south end and two on the north end of the bridge remained intact. The collapse happened very quickly - in about half an hour to an hour after the first span fell.
